Assessment of Dam Safety Coal Combustion Surface Impoundments (Task 3) Final Report

American Electric Power

Conesville
Generating Station

February 15, 2010

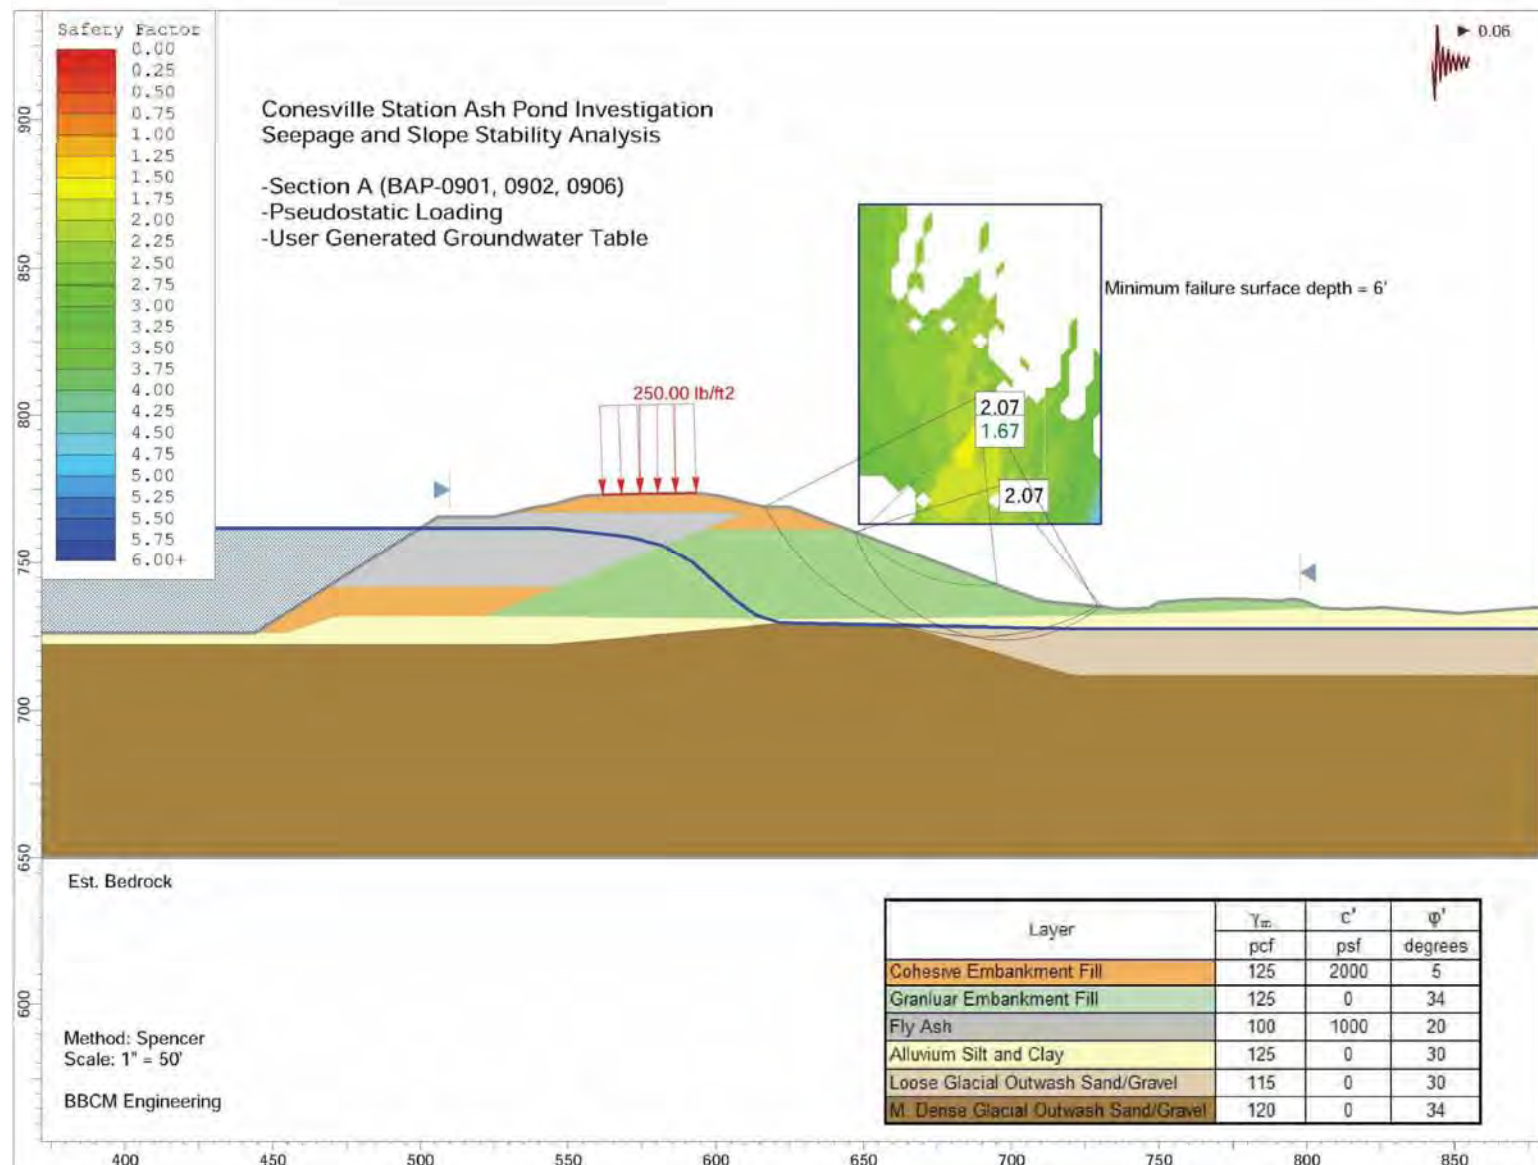
FIGURE 8B

Table 5 provides a summary of the calculated factors of safety for the loading conditions outlined by the U.S. Army Corps of Engineers in EM 1110-2-1902, Table 3-1. Figures 8A through 8C and Figures 9A through 9C show the stability analyses outputs summarized in Table 5.
